Household Inspection Team ®

**Your Confidential Property Inspection Report
of Property Location:**

08/03/2017

Inspection address: 1235 W. Scott St. Chicago, IL

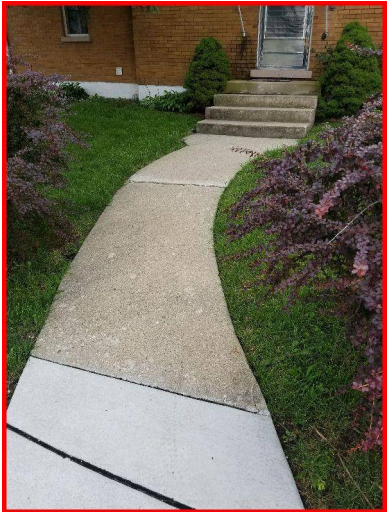
Sidewalk is concrete type. Surface raised / settled and could get worse over time. Recommend to have a concrete contractor evaluate.

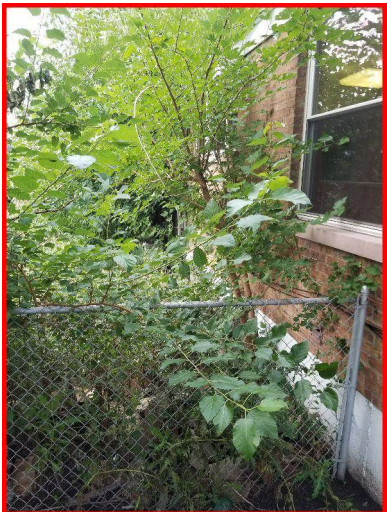
Trees are touching or overhanging the roof. Damage is possible, extra maintenance will be needed to keep roof and gutters clear of debris from tree. Recommend trimming back tree as possible.

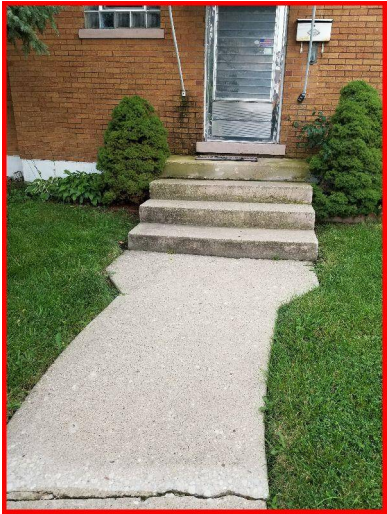
Stoop and walkway show some settlement - anticipate need for repair.
No handrail noted - recommend adding for safety.

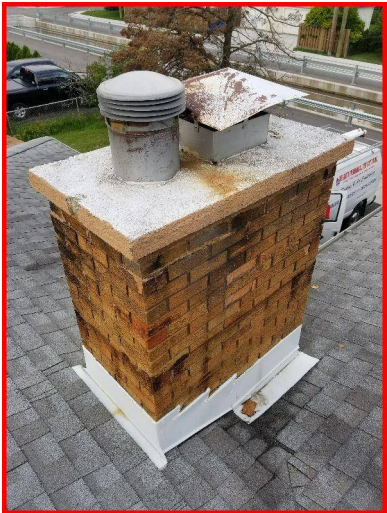
Signs of back venting hazard at water heater and heavy corrosion at furnace vent. Recommend further evaluation by a qualified contractor.

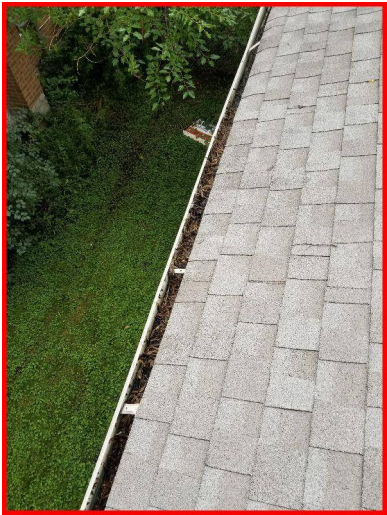
Debris noted in gutters. Clean gutters as needed to prevent damage to roof and trim materials. Homes with trees over roof area may need gutter cleaning several times a year.

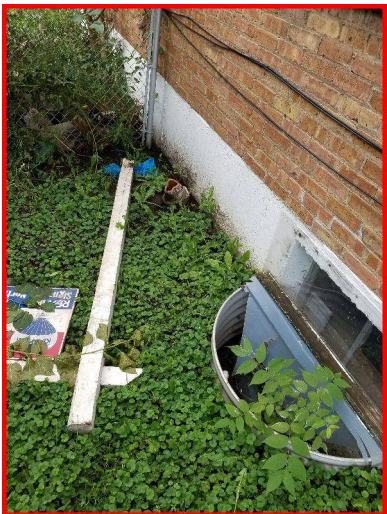
Conditions of underground drainage not determined with this limited inspection. Recommend sealing off unused drains.

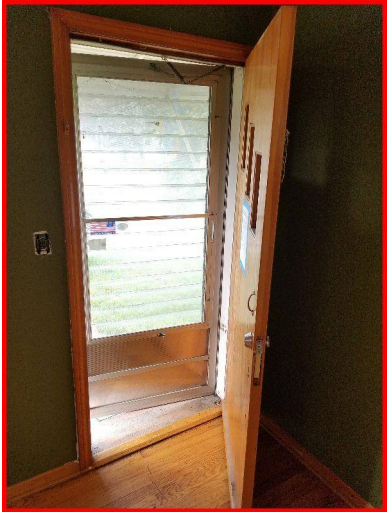
Older door shows some wear - maintenance recommended. Storm door deteriorated and repair or replacement recommended.

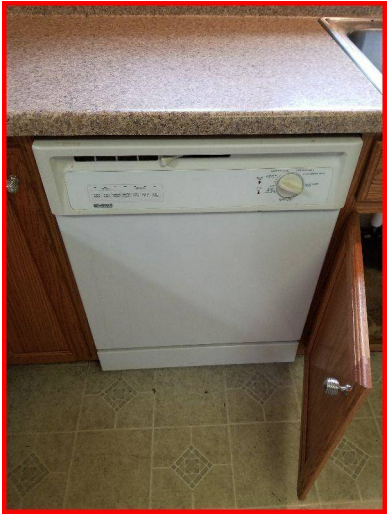
Appliance is an older model with only limited service life remaining. Recommend to budget to replace.

Typical life expectancy of dishwashers is 8 - 12 years. Not tested per buyer.

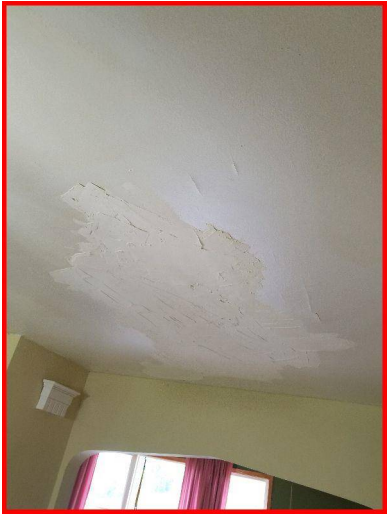
No moisture noted with limited meter spot testing. Recommend to ask seller history of patches noted in this room.

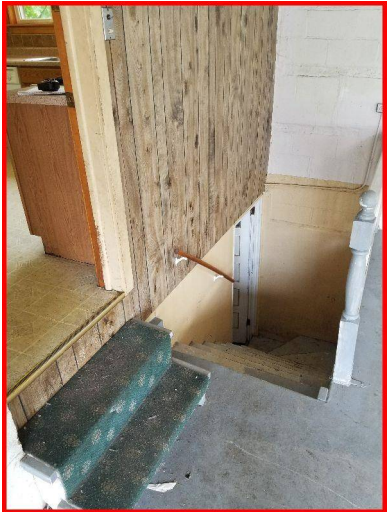
Tread off kitchen level is short - recommend correction. Guardrail off garage slab is weak and shows movement - recommend correction for safety.

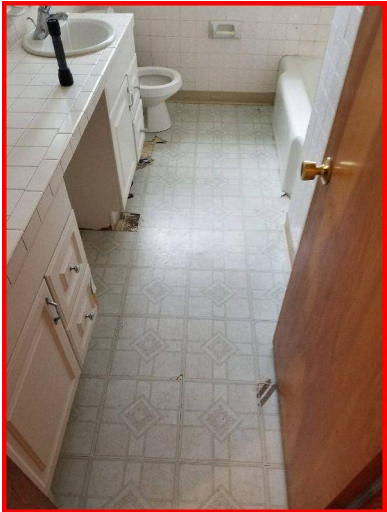
Vinyl deteriorated. Recommend further evaluation by a qualified contractor for proper repair by a qualified contractor.

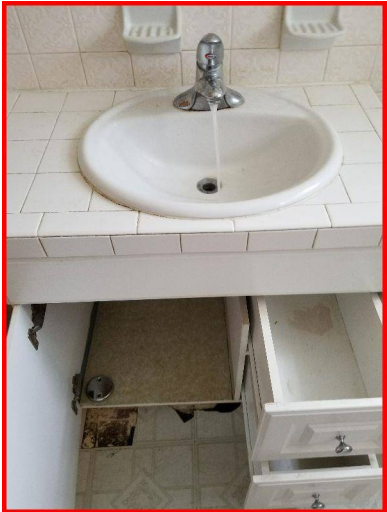
Low flow noted at faucet. Drain leaks and repair is recommended. Cabinet shows some wear.

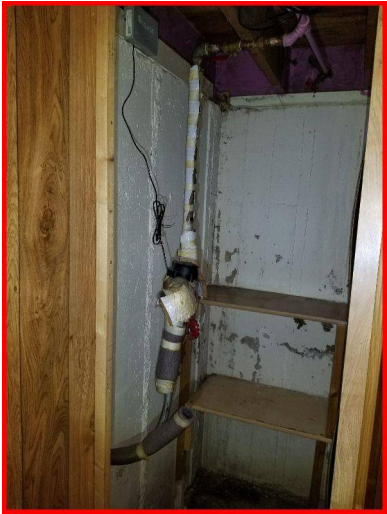
Active seepage noted at multiple spots on South wall. North wall suspect as well - but may be old stains from ejector basin area plumbing issues.

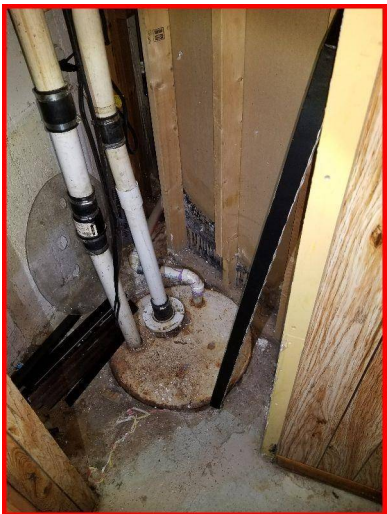
Symptoms of prior water entry exist, Additional water damage and possibly hazardous microbial growth may be concealed inside walls that were wet at one time. Foundation cracks or other defects may be covered by finished walls. Evaluating these conditions is beyond the scope of this inspection. Further evaluation including full or partial removal of wall materials at substantial expense may be needed to evaluate and correct the damage and the source of water. Recommend a further evaluation by a qualified contractor before the end of your attorney review period.

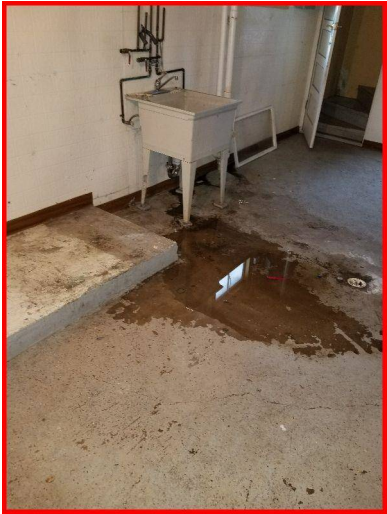
Water signs are noted on floor slab. Floor does not appear to be adequately pitched to drain. Recommend correction.

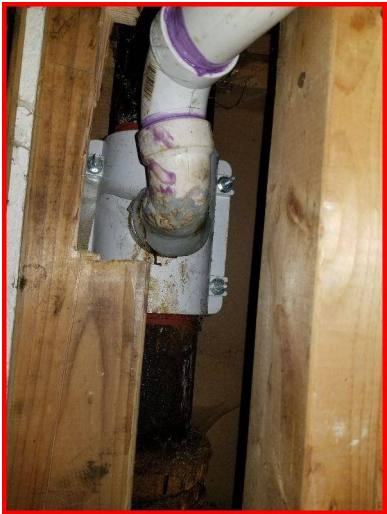
Ejector pump discharge pipe tap into cast iron waste line is bad - loose and with active leak - recommend repair by a qualified contractor.

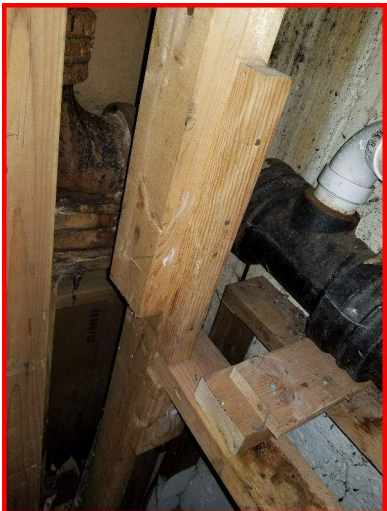
Leak noted below ejector pump discharge tap. Recommend further evaluation by a qualified contractor. Mold-like staining noted below.

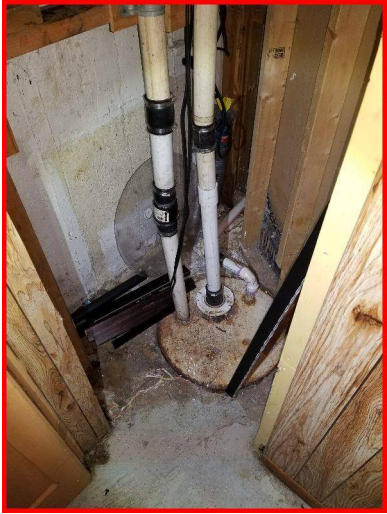
Ejector cover is not properly sealed, and sewer gas may enter home - recommend correction. Pump was activated by running basement bathroom fixtures. Conditions of underground drainage not determined with this limited inspection.

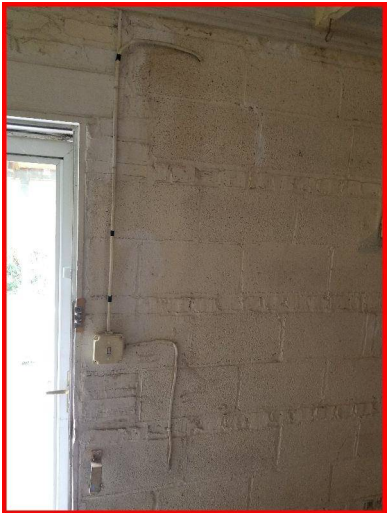
Romex. Noted sections of Romex (plastic sheathed wiring) in home, which is generally not approved for use by many cities in this area. Only a licensed electrician can review the proper use of such wiring. Recommend further review.

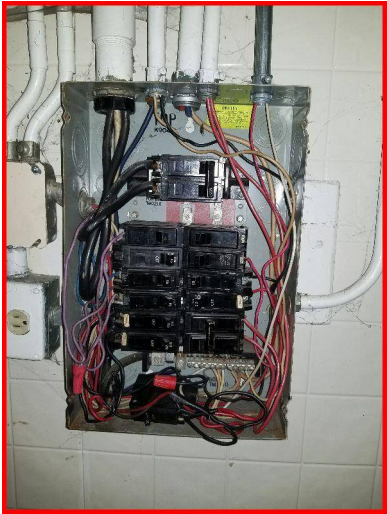
Recommend electrician evaluate to upgrade panel with matching breakers, more space for additional circuits, and correct splicing issues.

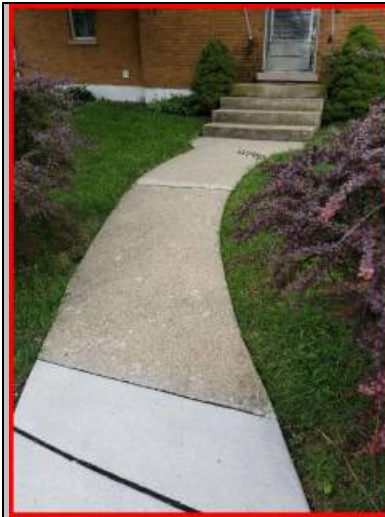
Sidewalk is concrete type. Surface raised / settled and could get worse over time. Recommend to have a concrete contractor evaluate.

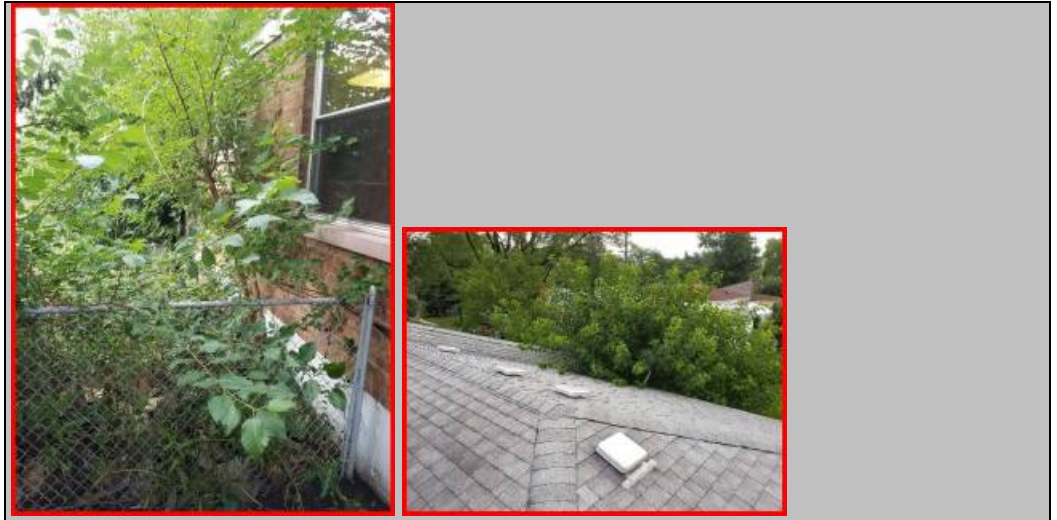
Trees are touching or overhanging the roof. Damage is possible, extra maintenance will be needed to keep roof and gutters clear of debris from tree. Recommend trimming back tree as possible.

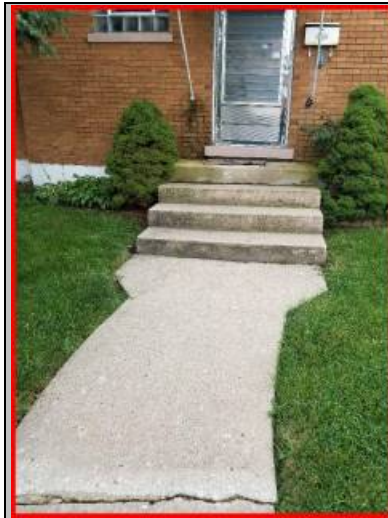
Stoop and walkway show some settlement - anticipate need for repair.
No handrail noted - recommend adding for safety.

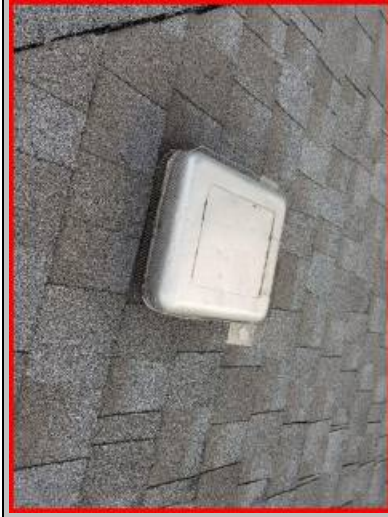
Metal roof vents show some signs of past hail exposure - small indentations. Recommend further evaluation by a qualified roofing contractor.

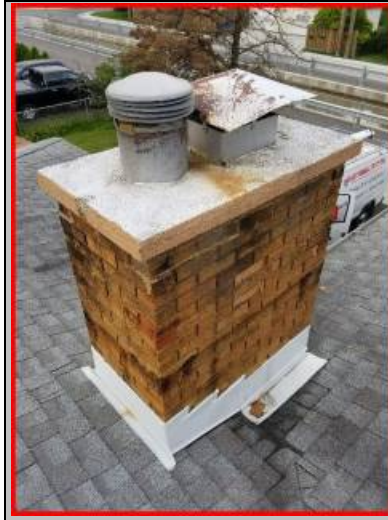
Signs of back venting hazard at water heater and heavy corrosion at furnace vent. Recommend further evaluation by a qualified contractor.

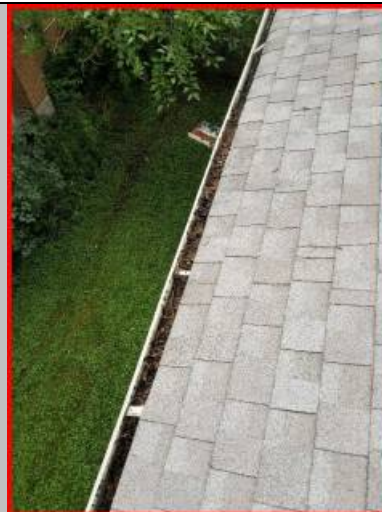
Downspouts discharge too close to building foundation. Water draining against foundation can cause serious damage to structure and water leakage into basement over time. Route downspouts away from the building as possible, ten feet is recommended. Consult a basement waterproofing contractor or a qualified landscaping professional for options on correcting downspout discharge.

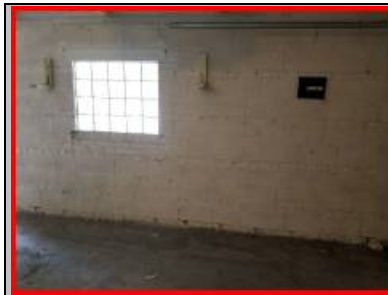
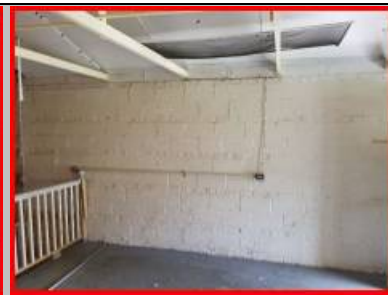
Concrete block. Minor cracks noted. Monitor.

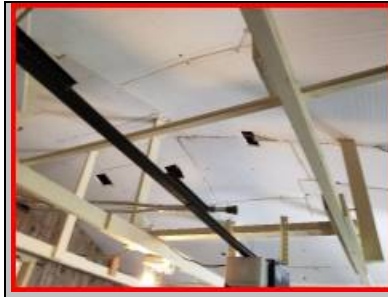
Exposed foam insulation panels are combustible - recommend removal. Insulation panels limited inspection access and view of framing.

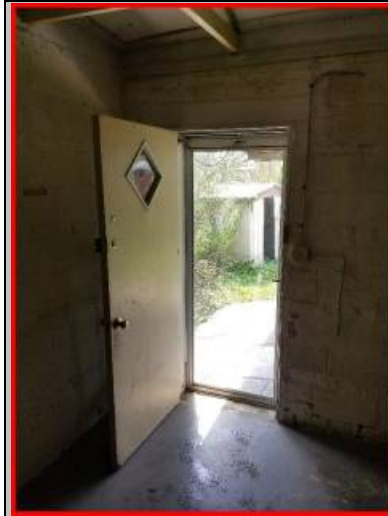
Older door shows wear. Maintenance recommended.

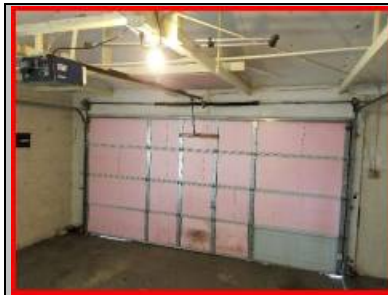
Door operational. Recommend adjusting door seal, as gap may allow for pest entry issues.
Electric opener operational.

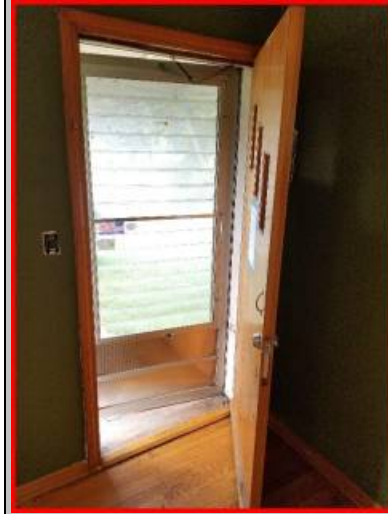
Older door shows some wear - maintenance recommended. Storm door deteriorated and repair or replacement recommended.

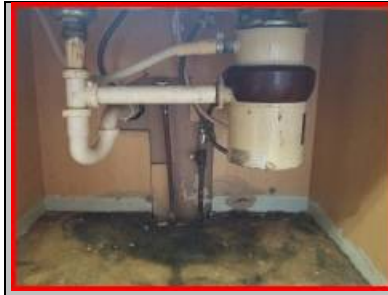
Appliance is an older model with only limited service life remaining. Recommend to budget to replace. Typical life expectancy of disposal is 8 - 12 years. Unit is not working and should be evaluated. A qualified plumber should be called to make further evaluation and repair as needed.

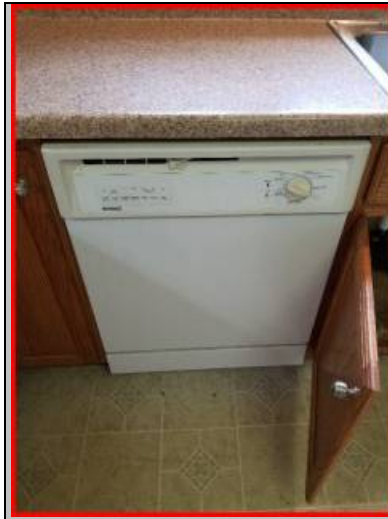
Appliance is an older model with only limited service life remaining. Recommend to budget to replace. Typical life expectancy of dishwashers is 8 - 12 years. Not tested per buyer.

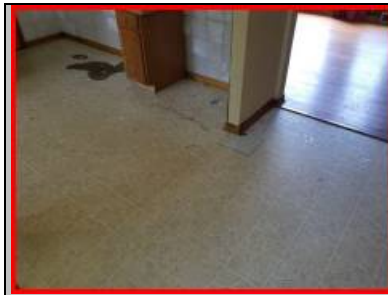
Vinyl and linoleum. Torn and worn at spots. Recommend further evaluation for proper repair by a qualified contractor.

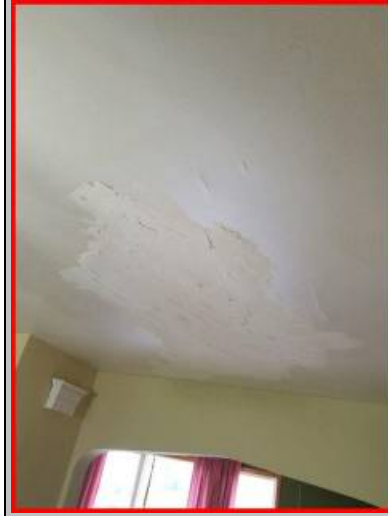
No moisture noted with limited meter spot testing. Recommend to ask seller history of patches noted in this room.

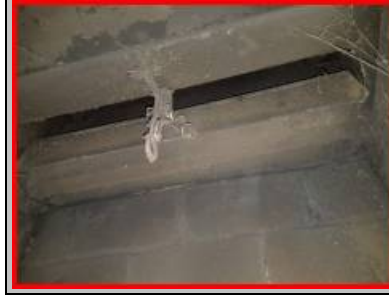
Damper operational. Limited view of the flue from the fire box only. Recommend further evaluation by a qualified contractor to verify conditions before use.

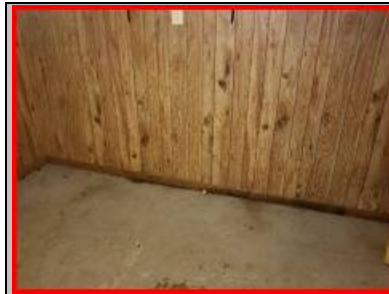
South wall. Stain was wet when tested with moisture meter at time of inspection. Recommend to have a professional evaluate this area located in this room.

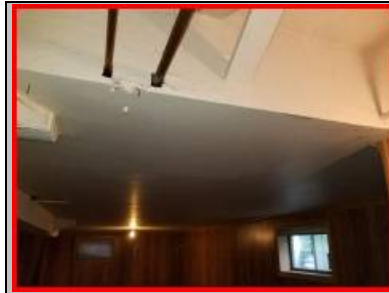
Stain was wet when tested with moisture meter at time of inspection. Recommend to have a professional evaluate this area located in this room.

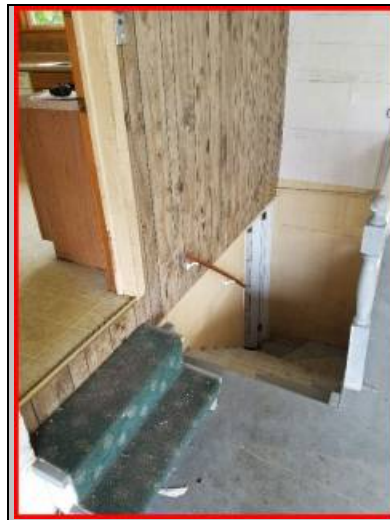
Tread off kitchen level is short - recommend correction. Guardrail off garage slab is weak and shows movement - recommend correction for safety.

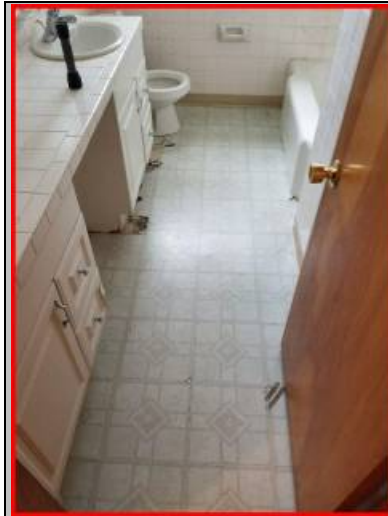
Vinyl deteriorated. Recommend further evaluation by a qualified contractor for proper repair by a qualified contractor.

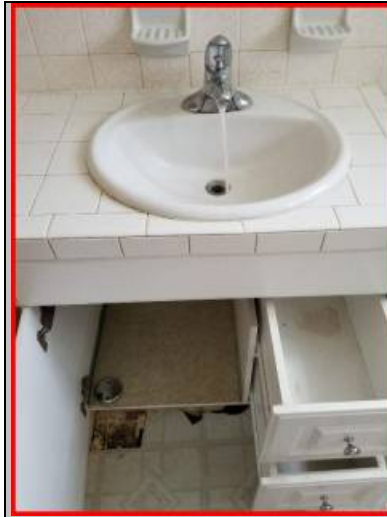
Low flow noted at faucet. Drain leaks and repair is recommended. Cabinet shows some wear.

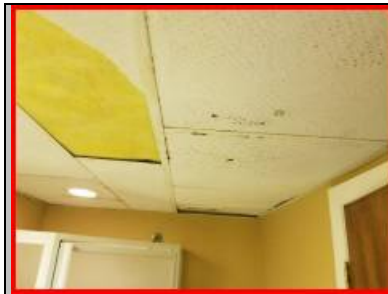
Stain was dry when tested with moisture meter at time of inspection. Recommend to get history of stain located in this room.

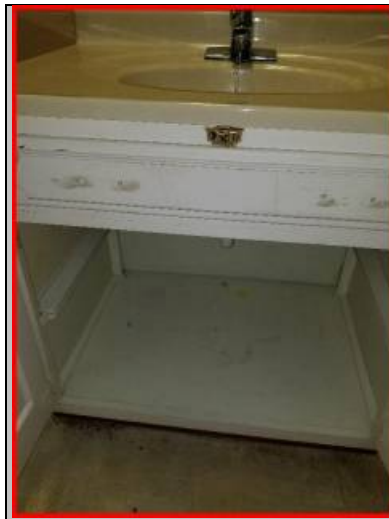
Older faucet shows reduced flow with multiple fixtures on- recommend further evaluation by a qualified contractor. Drain flow generally serviceable.

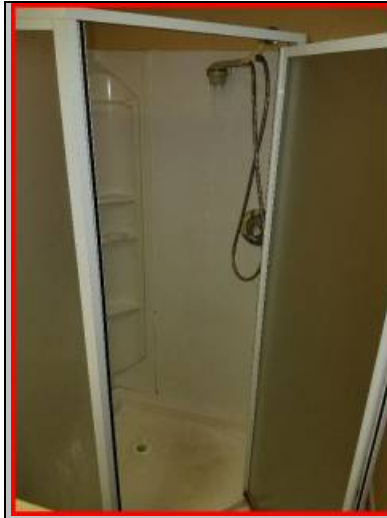
Shower fixture operational but head connection leaks and repair is recommended. Drain missing grated cover.

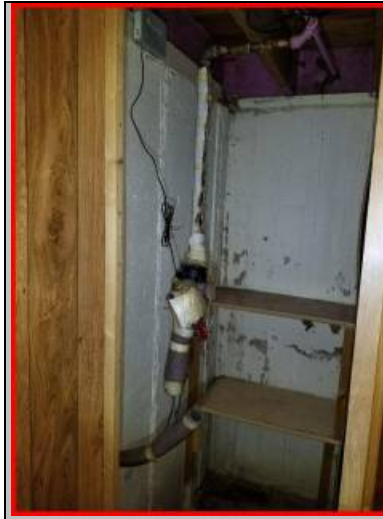
Active seepage noted at multiple spots on South wall. North wall suspect as well - but may be old stains from ejector basin area plumbing issues.

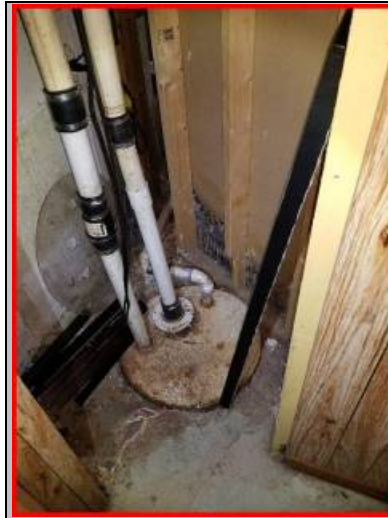
Symptoms of prior water entry exist, Additional water damage and possibly hazardous microbial growth may be concealed inside walls that were wet at one time. Foundation cracks or other defects may be covered by finished walls. Evaluating these conditions is beyond the scope of this inspection. Further evaluation including full or partial removal of wall materials at substantial expense may be needed to evaluate and correct the damage and the source of water. Recommend a further evaluation by a qualified contractor before the end of your attorney review period.

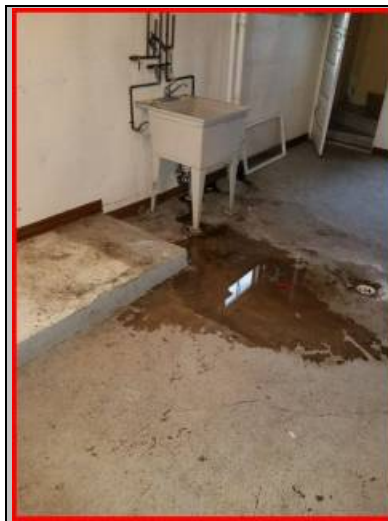
Water signs are noted on floor slab. Floor does not appear to be adequately pitched to drain. Recommend correction.

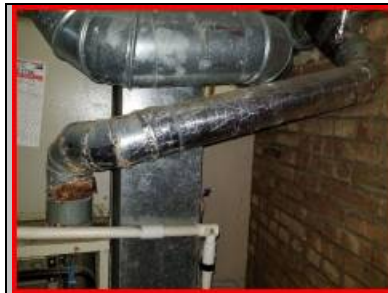
Corrosion noted on metal flue. This condition may be a result of flue gases that did not expel up the flue. The flue gases cooled, condensed on their way back down the flue, and the resulting aldehyde deteriorated the metal flue. Recommend to have this issue remedied by a HVAC technician as this is a safety issue.

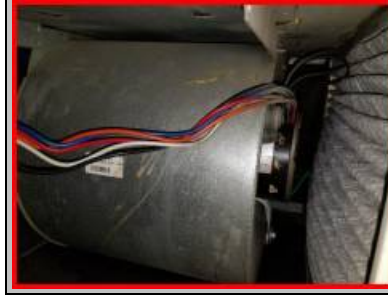
Blower motor may be going bad, with capacitor burning up. Recommend further evaluation by a qualified contractor for proper repair.

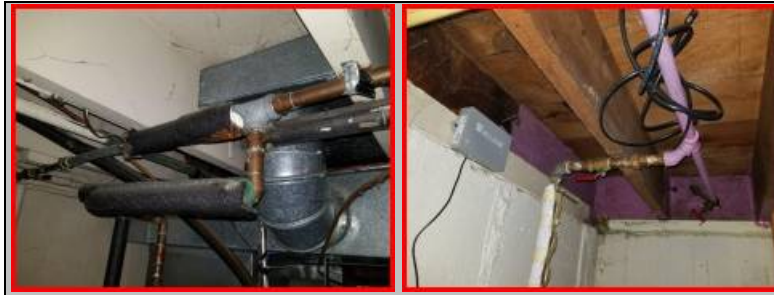
Ceiling area wet - see basement family room notes - recommend further evaluation by a qualified contractor of piping run thru area for leak. Noted reduced flow with multiple fixtures on. Recommend further evaluation by a qualified plumbing contractor for possible galvanized piping replacement.

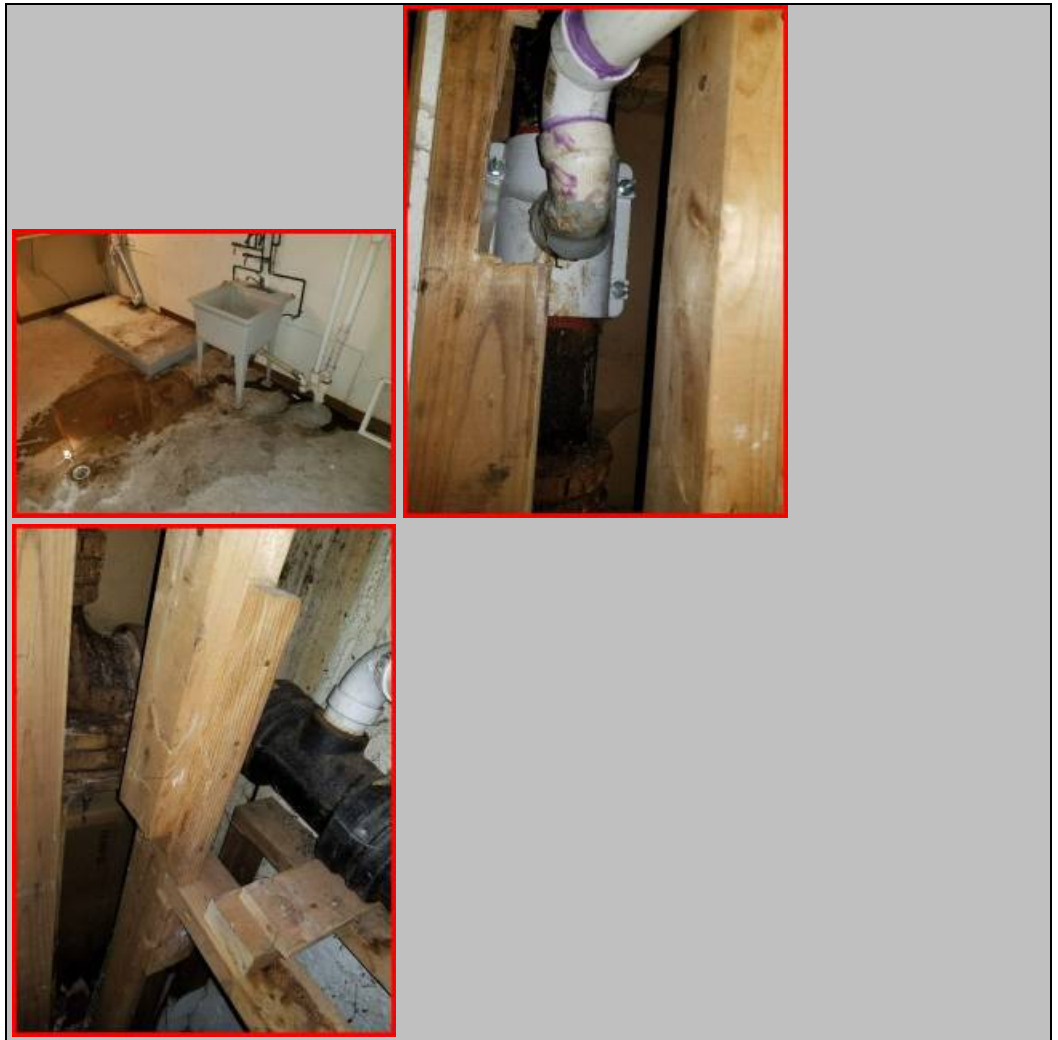
Leak noted below ejector pump discharge tap. Recommend further evaluation by a qualified contractor. Mold-like staining noted below.

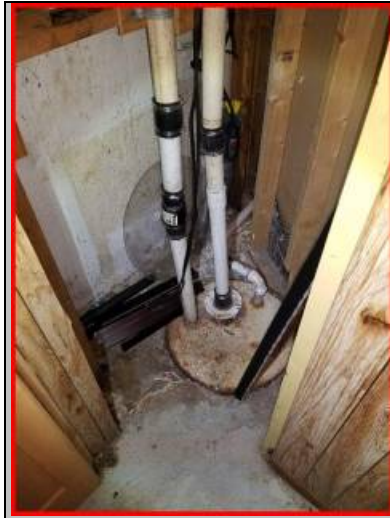
Ejector cover is not properly sealed, and sewer gas may enter home - recommend correction. Pump was activated by running basement bathroom fixtures. Conditions of underground drainage not determined with this limited inspection.

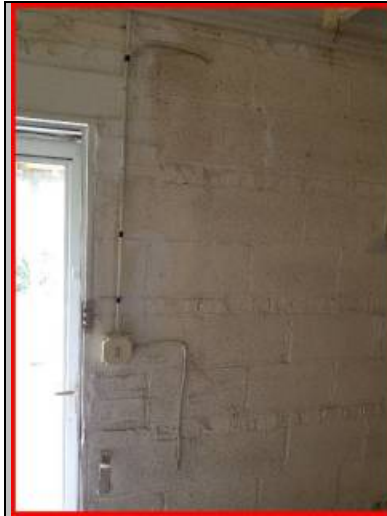
Romex. Noted sections of Romex (plastic sheathed wiring) in home, which is generally not approved for use by many cities in this area. Only a licensed electrician can review the proper use of such wiring. Recommend further review.
