Household Inspection Team ®

**Your Confidential Property Inspection Report
of Property Location:**

08/03/2017

Inspection address: 1235 W. Scott St. Chicago, IL

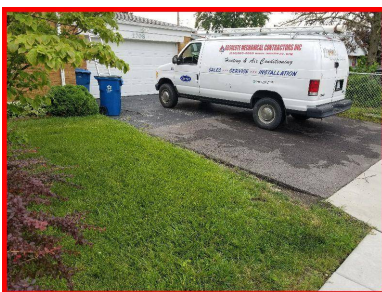
Driveway is asphalt type and needs to be sealed every couple years for maintenance purposes. Cracks noted are typical.

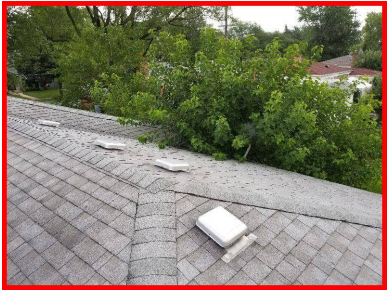
Trees are touching or overhanging the roof. Damage is possible, extra maintenance will be needed to keep roof and gutters clear of debris from tree. Recommend trimming back tree as possible.

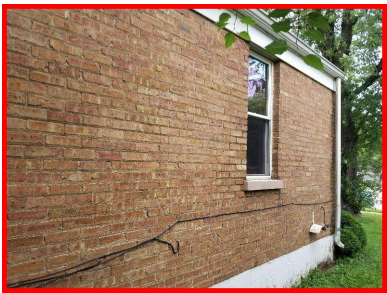
Typical cracks and wear noted at mortar joints. Recommend further evaluation by a qualified masonry contractor for re-pointing maintenance. Recommend sealing openings around utility penetrations.

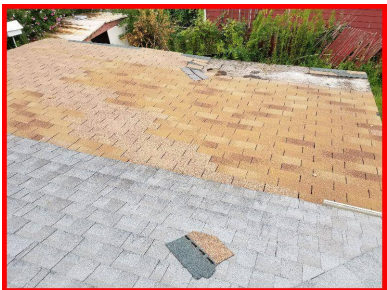
Roof and roof support deteriorated at spots. Posts show moisture rot. Shingles missing and roof decking damaged. Recommend further evaluation by a qualified contractor for proper repair.

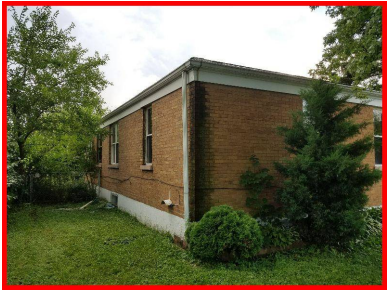
Water leaks noted in gutter system - several spots.

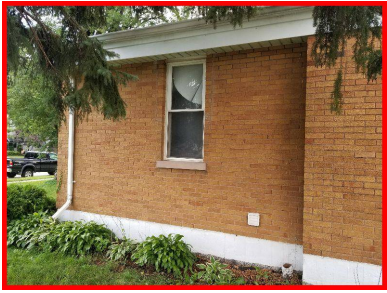
Downspouts discharge too close to building foundation. Water draining against foundation can cause serious damage to structure and water leakage into basement over time. Route downspouts away from the building as possible, ten feet is recommended. Consult a basement waterproofing contractor or a qualified landscaping professional for options on correcting downspout discharge.

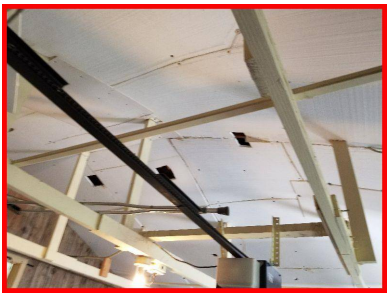
Exposed foam insulation panels are combustible - recommend removal. Insulation panels limited inspection access and view of framing.

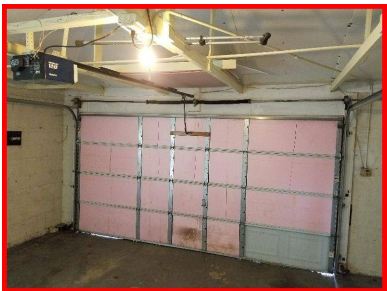
Door operational. Recommend adjusting door seal, as gap may allow for pest entry issues. Electric opener operational.

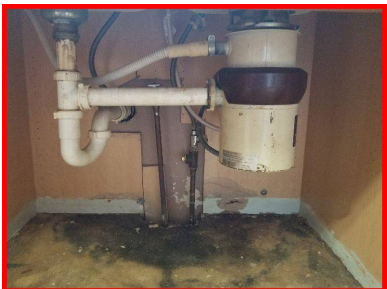
Typical life expectancy of disposal is 8 - 12 years. Unit is not working and should be evaluated. A qualified plumber should be called to make further evaluation and repair as needed.

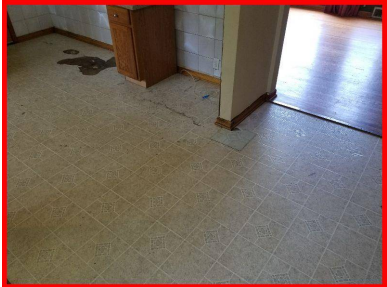
Vinyl and linoleum. Torn and worn at spots. Recommend further evaluation for proper repair by a qualified contractor.

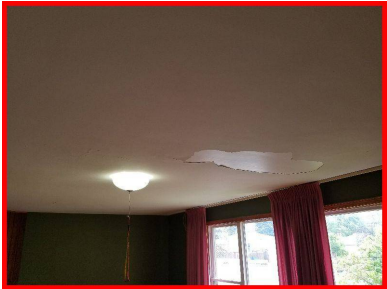
No moisture noted with limited meter spot testing at this time. Recommend to ask seller history of patches noted in this room.

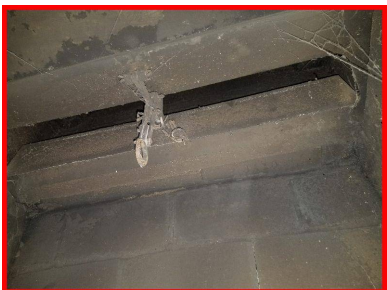
Damper operational. Limited view of the flue from the fire box only. Recommend further evaluation by a qualified contractor to verify conditions before use.

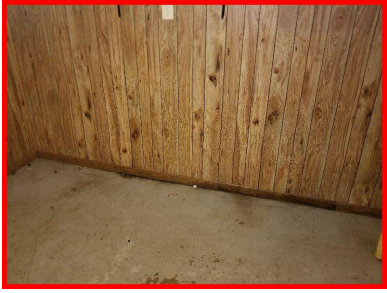
South wall. Stain was wet when tested with moisture meter at time of inspection. Recommend to have a professional evaluate this area located in this room.

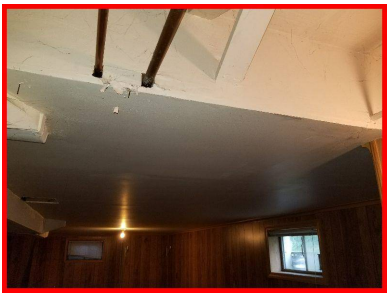
Stain was wet when tested with moisture meter at time of inspection. Recommend to have a professional evaluate this area located in this room.

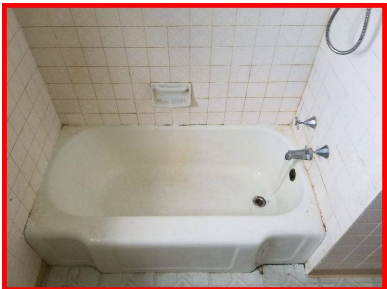
Tub finish worn. Tike loose and deteriorated at spots. Recommend further evaluation by a qualified contractor for proper repair.

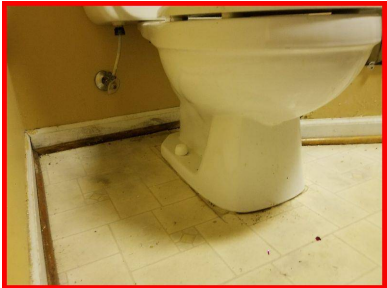
Stain was dry when tested with moisture meter at time of inspection. Recommend to get history of stain located in this room.

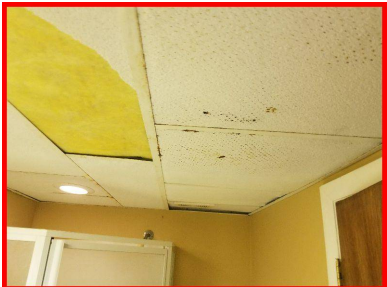
Stain was dry when tested with moisture meter at time of inspection. Recommend to get history of stain located in this room.

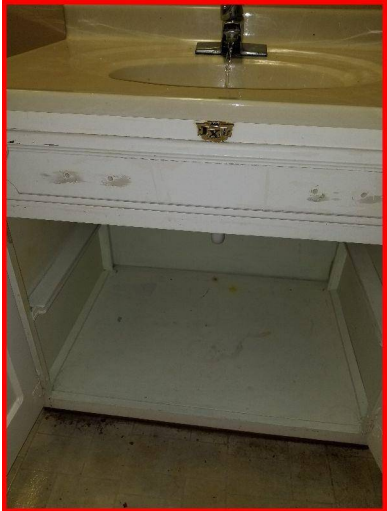
Older faucet shows reduced flow with multiple fixtures on- recommend further evaluation by a qualified contractor. Drain flow generally serviceable.

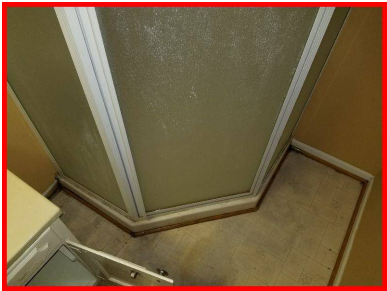
Cosmetic moisture damage is noted at the wall or floor outside the tub/shower area. Recommend further evaluation by a qualified contractor for proper repairs.

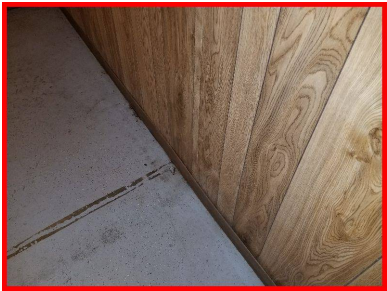
Active seepage noted at multiple spots on South wall. North wall suspect as well - but may be old stains from ejector basin area plumbing issues.

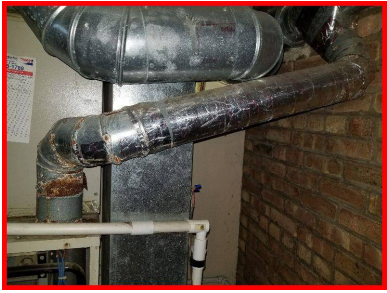
Corrosion noted on metal flue. This condition may be a result of flue gasses that did not expel up the flue. The flue gasses cooled, condensed on their way back down the flue, and the resulting aldehyde deteriorated the metal flue. Recommend to have this issue remedied by a HVAC technician as this is a safety issue.

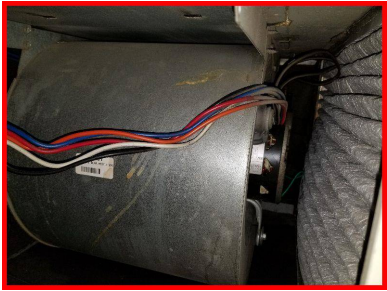
Blower motor may be going bad, with capacitor burning up. Recommend further evaluation by a qualified contractor for proper repair.

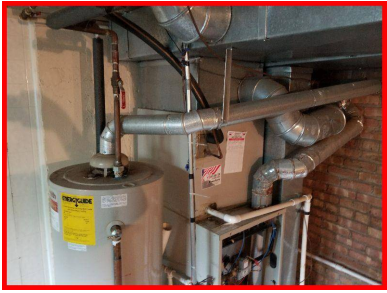
Signs of back venting hazard at water heater and heavy corrosion noted at furnace flue - Recommend further evaluation of the chimney by a qualified contractor. A liner may be needed.

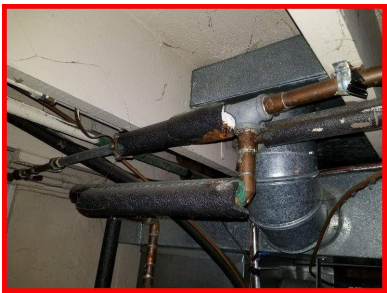
Corrosion noted. Copper / Galvanized piping connections are noted without the use of proper dielectric unions. Contact between copper and galvanized piping can cause corrosion in copper piping system. Recommend further review by a qualified plumbing contractor.

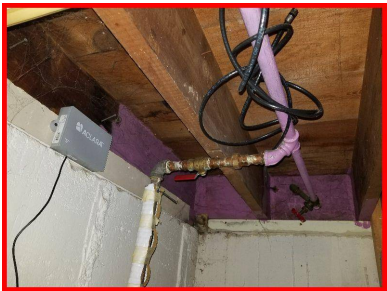
Area off water main. Copper / Galvanized piping connections are noted without the use of proper dielectric unions. Contact between copper and galvanized piping can cause corrosion in copper piping system. Recommend further review by a qualified plumbing contractor.

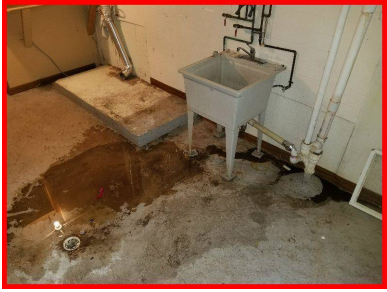
Kitchen waste line appears to feed into the ejector basin via the laundry sink and floor drain route - not recommended. Recommend a qualified plumber determine if a catch basin was bypassed. Recommend a qualified plumber evaluate to re-route kitchen waste line to North wall main waste line to avoid ejector basin feed with above grade waste.

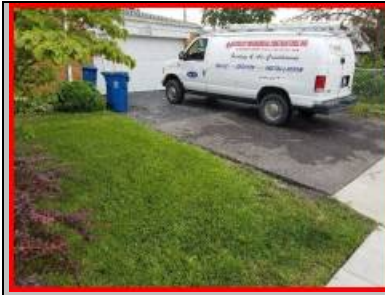
Driveway is asphalt type and needs to be sealed every couple years for maintenance purposes. Cracks noted are typical.

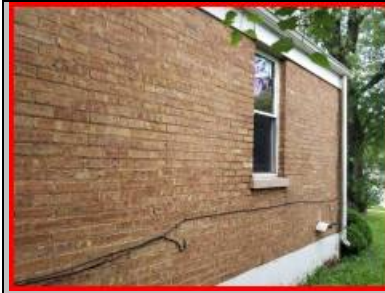
Typical cracks and wear noted at mortar joints. Recommend further evaluation by a qualified masonry contractor for re-pointing maintenance. Recommend sealing openings around utility penetrations.

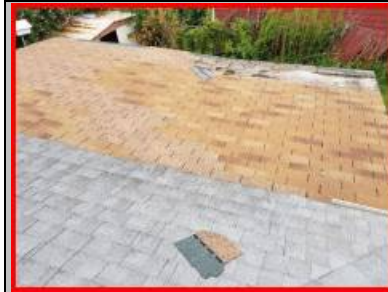
Roof and roof support deteriorated at spots. Posts show moisture rot. Shingles missing and roof decking damaged. Recommend further evaluation by a qualified contractor for proper repair.

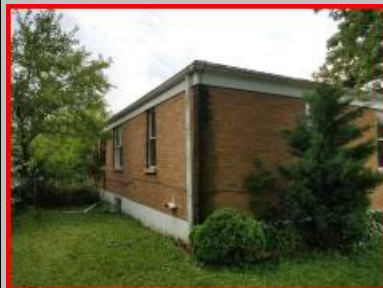
Downspouts discharge too close to building foundation. Water draining against foundation can cause serious damage to structure and water leakage into basement over time. Route downspouts away from the building as possible, ten feet is recommended. Consult a basement waterproofing contractor or a qualified landscaping professional for options on correcting downspout discharge.

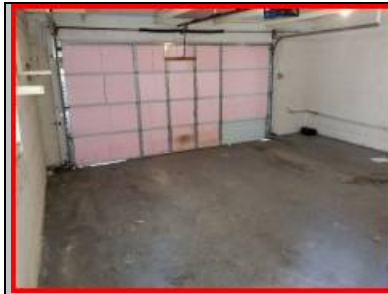
CONDITION:

Acceptable condition.

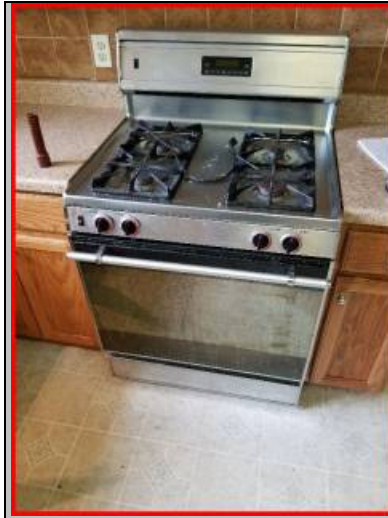
Range:

Gas. Unplugged and not tested.

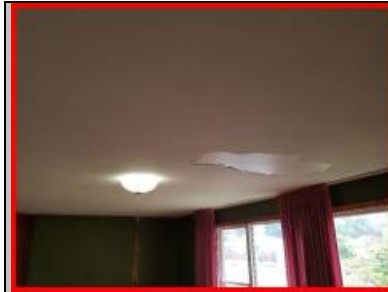
Ceilings:

No moisture noted with limited meter spot testing at this time. Recommend to ask seller history of patches noted in this room.

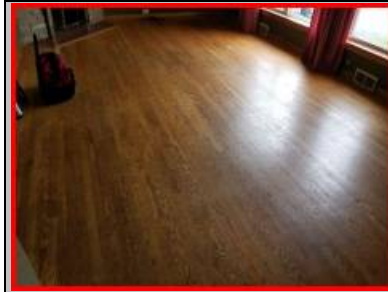
Floors:

Wood flooring shows some general wear with age.

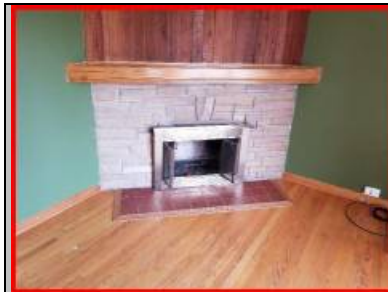
Fireplace Type:

Masonry, Wood burning.

Fireplace:

Damper operational. Limited view of the flue from the fire box only. Recommend further evaluation by a qualified contractor to verify conditions before use.

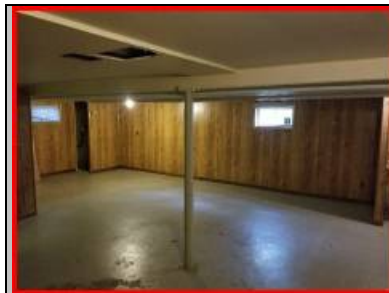
Floors:

Concrete.

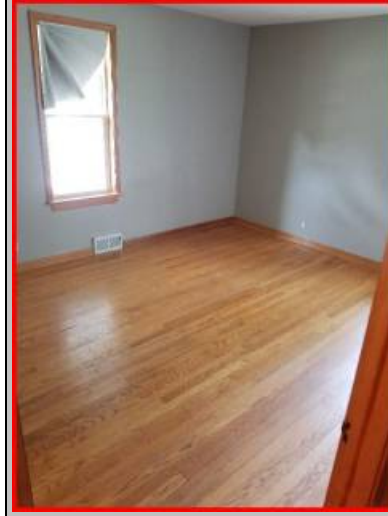
Floors:

Wood flooring shows some general wear with age.

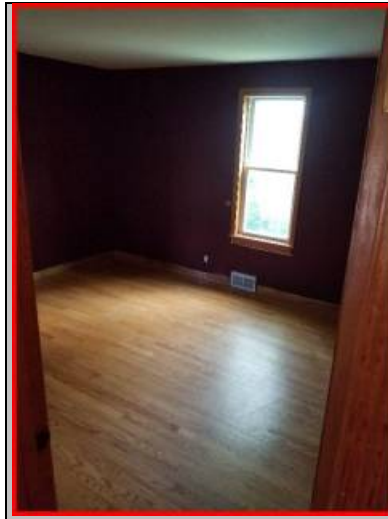
Floors:

Wood flooring shows some general wear with age.

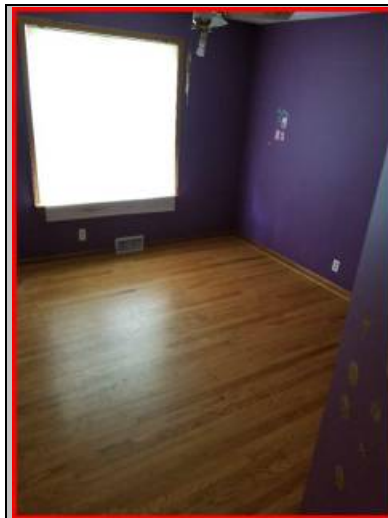
Floors:

Wood flooring shows some general wear with age.

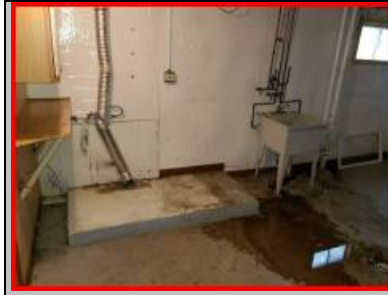
Location:

Washer and dryer area is located in the basement.

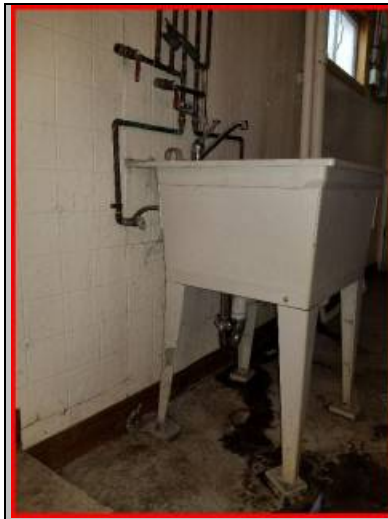
Sink Condition:

Faucet operational. Drain flow generally serviceable. Monitor drain for corrosion.

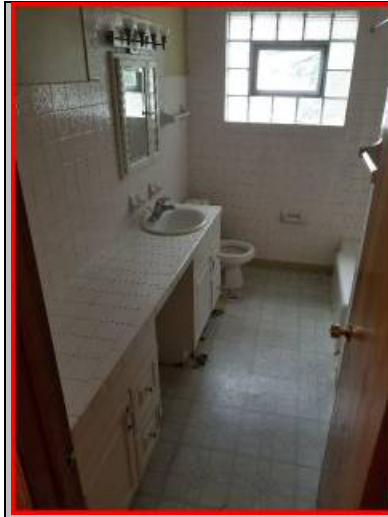
LOCATION:

Bathroom is located on first floor hallway.

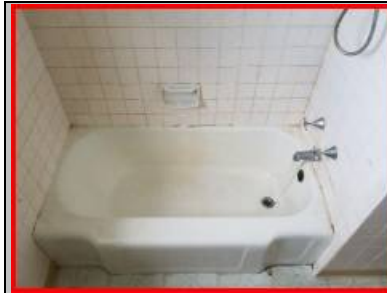
TUB / SHOWER Stall

Tub finish worn. Tile loose and deteriorated at spots. Recommend further evaluation by a qualified contractor for proper repair.

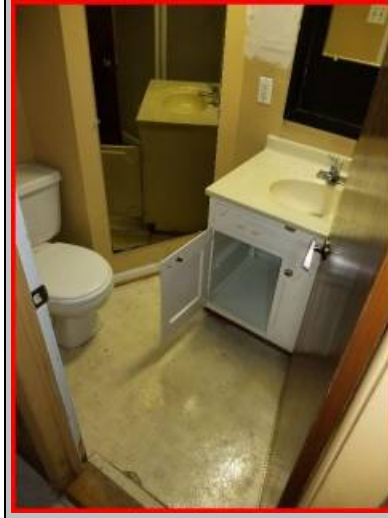
LOCATION:

Basement.

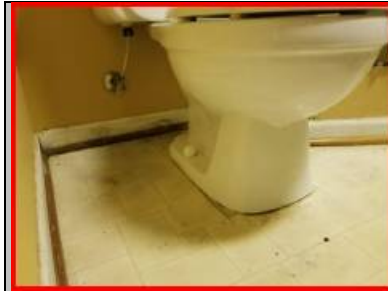
Walls:

Stain was dry when tested with moisture meter at time of inspection. Recommend to get history of stain located in this room.

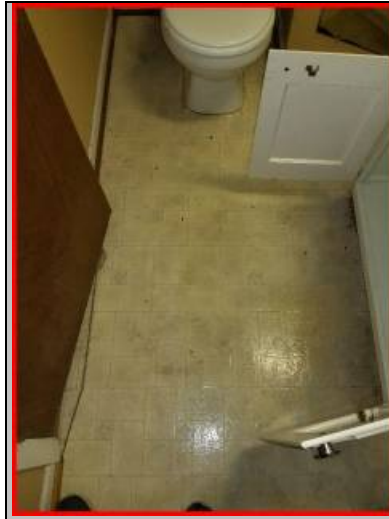
Floors:

Vinyl/Linoleum shows some wear and discoloration.

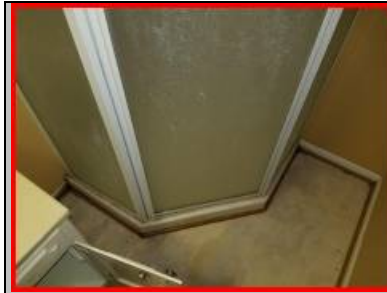
SHOWER Stall

Cosmetic moisture damage is noted at the wall or floor outside the tub/shower area. Recommend further evaluation by a qualified contractor for proper repairs.

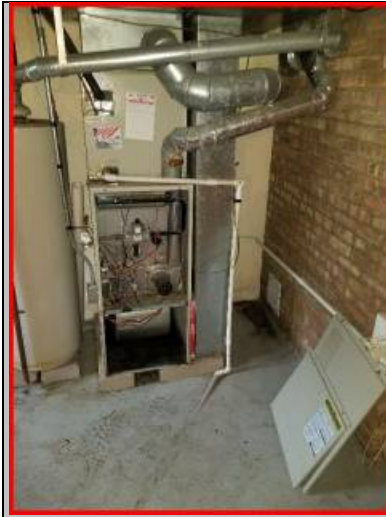
Location:

Basement.

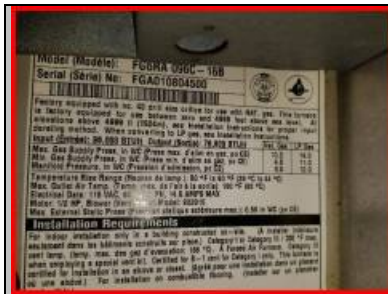
Identification tag:

Photo.

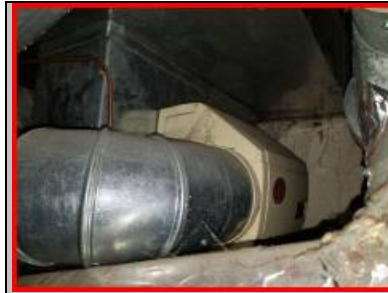
Humidifier:

Bypass model. Limited test due to Conditions of furnace.

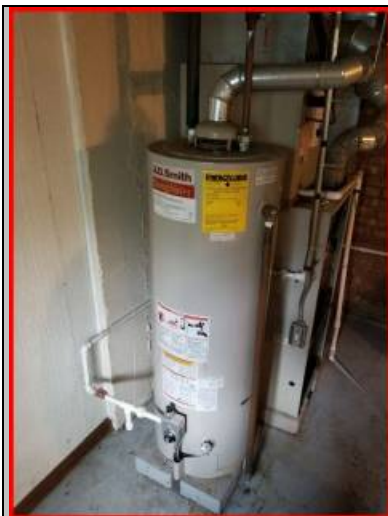
Type:

Water is stored in water heater tank. Tanks have a life expectancy of 9 - 12 years.

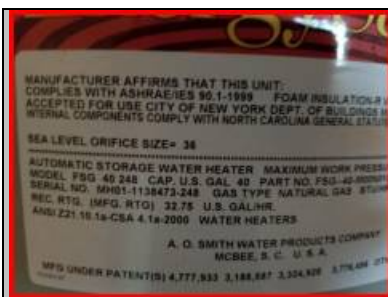
Identification tag:

Photo.

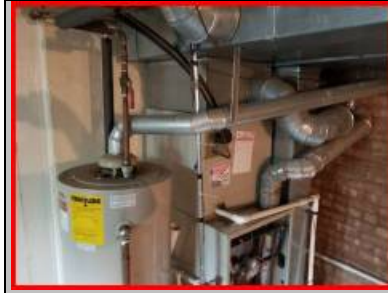
Flue Condition:

Signs of back venting hazard at water heater and heavy corrosion noted at furnace flue
- Recommend further evaluation of the chimney by a qualified contractor. A liner may be needed.

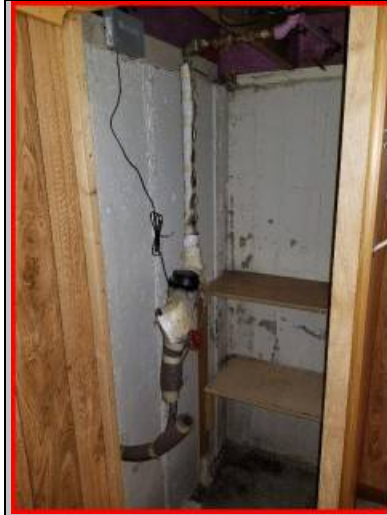
LOCATION

Basement east wall.

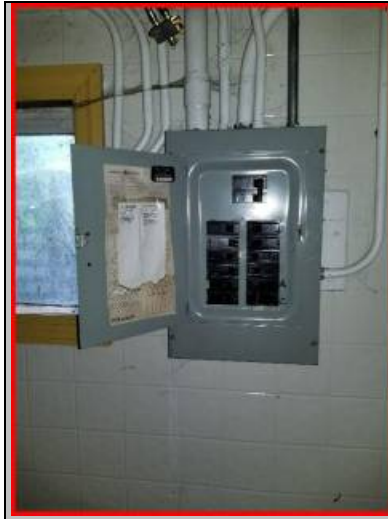
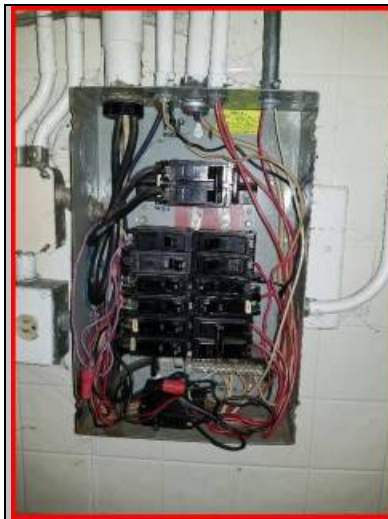
Panel Condition:

Splicing noted within panel, including service neutral - not recommended. Recommend further evaluation by a qualified contractor for proper repair.
Breakers do not fit properly in panel - hazard. Recommend further evaluation by a qualified contractor for proper repair.
Recommend electrician evaluate to upgrade panel with matching breakers, more space for additional circuits, and correct splicing issues.

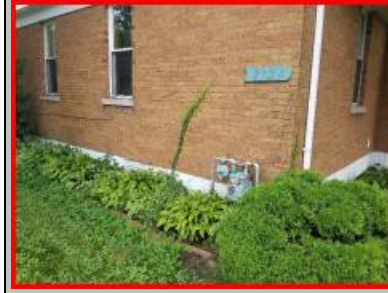
MAIN NATURAL GAS SHUT OFF LOCATION

Gas meter / shut off located at exterior - Left side when facing front.
